Sand-Cement Concrete in the Century-Old Camarasa Dam

A. Blanco, Ph.D.¹; I. Segura, Ph.D.²; S. H. P. Cavalaro, Ph.D.³;
S. Chinchón-Payá, Ph.D.⁴; and A. Aguado, Ph.D.⁵

Author keywords: Sand-cement; Concrete dam; Freeze-thaw cycle; Leaching.

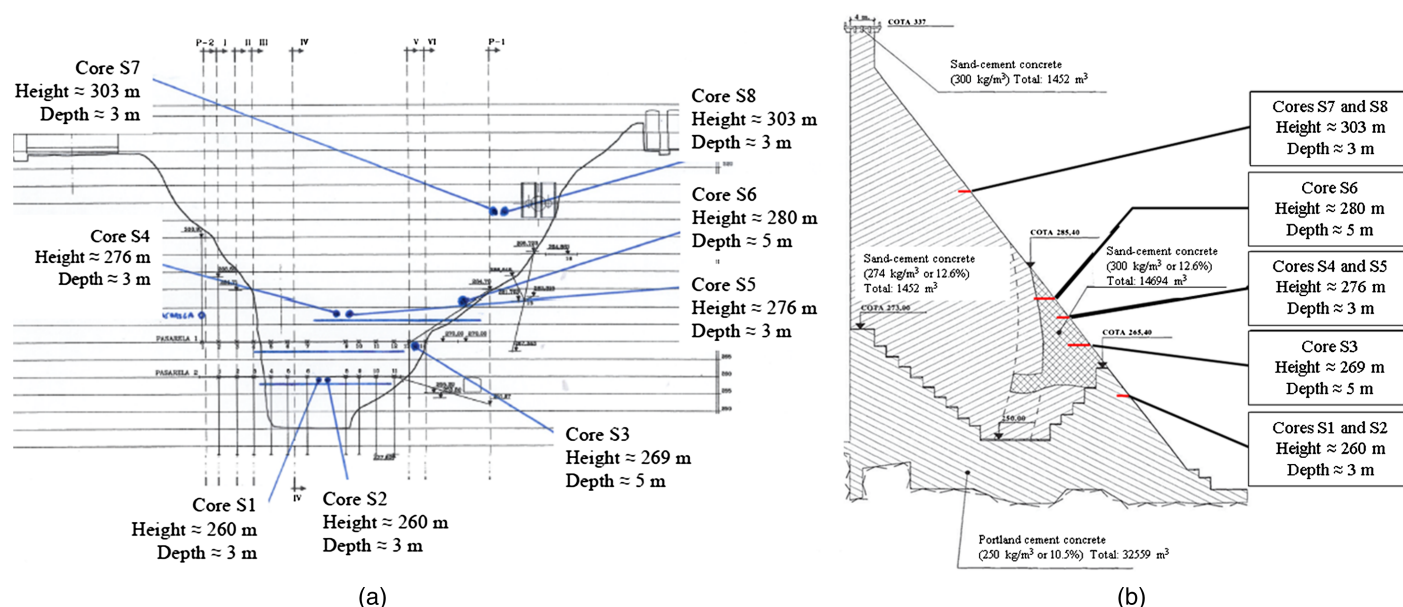
For T1, twin cores were drilled at three different heights, making a total of six cores of 3.0 m, and for T2, two cores were extracted at two levels, thus resulting in four cores of 5.0 m. In all cases, the diameter of the drill-bit was 75 mm and the resulting diameter of the cores was measured. The location of the drills in the downstream face and in the lateral view is presented in Fig. 2.

Fig. 2. Location of the cores in (a) downstream face; (b) lateral view (reprinted from [ENDESA 2011](#), with permission)
